X-Ray Technology

General Electric (GE) Bravo DEXA Scan System

Mercy Health/Love County

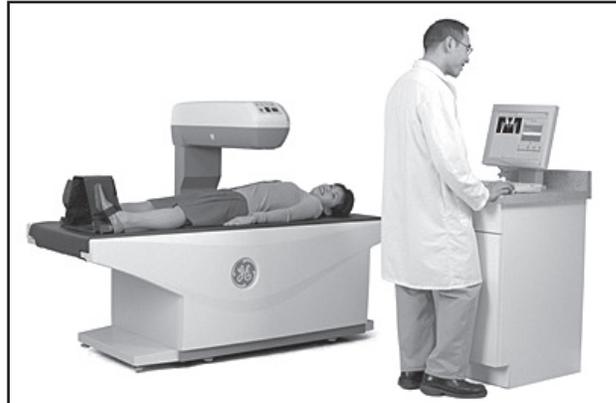
A scanning arm passes over the body to measure bone density in the center of the skeleton, usually hip and lower spine.

Unlike ordinary x-ray images, DEXA scans can measure very small reductions in bone mineral density. This makes it possible to diagnose osteoporosis in the early stages, before fractures occur.
